NC Division of Water Quality
Planning Section
Modeling and TMDL Unit

MEMORANDUM

Date: October 6, 2009
Subject: Assessment of Natural Condition for DO and pH in Potecasi Creek,
Chowan River Basin, NC

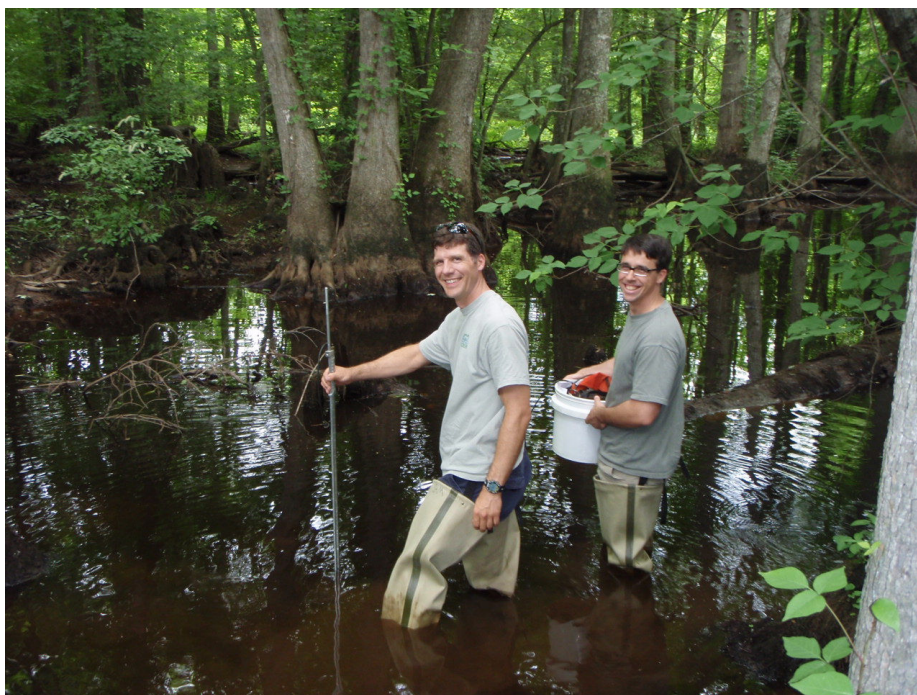
Figure 9. Measuring flow velocity at Potecasi Creek at SR35, May 27, 2009.
The DWQ staff from left Christopher S. Whitaker and Peter Caldwell.

The DWQ staff also measured flow velocity in the mid stream of Potecasi at SR35 using Marsh McBirney Magnetic Flow Meter (Model #201). The velocity was below its detection limit.
